# ARE WE REALLY LEARNING" A Case study- Still Going Wrong" PRAKASH TATA, Author

This Presentation which is part of my forthcoming book titled "Are We Really Learning?" whose idea got inspiration from Last ASSP PDC where I got inspiration to go through all global catastrophic incidents. In this book I am working on a new age "Process Safety Management" process - "MLW-CAR-TOWARDS SOCIETAL RISK"

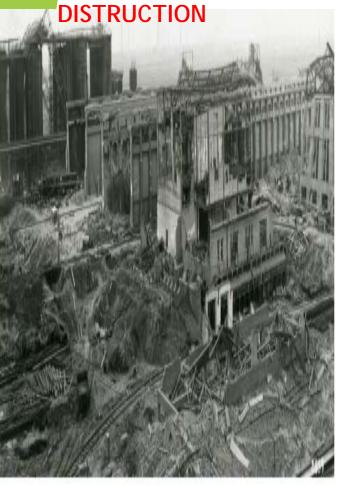
#### NEIGHBOURHOOD DISTRUCTION

- It can be assumed that on the day of the accident at least one of the explosions for loosening the caked salt was carried out in the area of the fine fraction, thus initiating a detonation of this fine fraction and causing the detonation of further fractions with approximately "normal" nitrate content.
- This accident is a strong example for the need of Management of Change (MOC) procedures, which are an integral part of today's process safety.
- ➤ Lack of care by operators induced by introduction of a new bonus system which was linked to the production quantity
- Introduction of the new spray process Deviations from the operating procedures resulting in the addition of wrong amounts of AS (too little) or AN (too high)
- Fine dust in 100 of tons ignored settling down with a thickness of 0.5m has created as dust cloud which lead to the explosion.

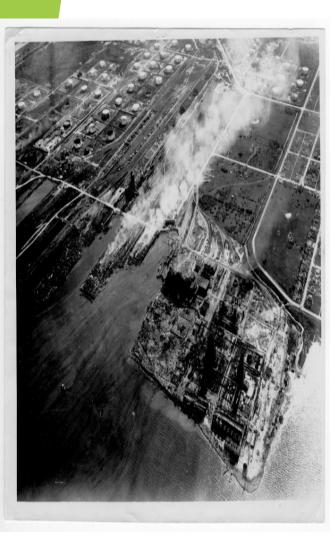
## APRIL 16, 1947- TEXAS CITY, USA

SS GRANDCAMP Explosion at Texas Port

- carrying combustible material sisal, cotton and peanuts, small arms ammunition and Ammonium Nitrate bags produced during war time and later to be used as fertilizer.
- Early in the morning fire was caught.
- > The ship exploded while fire control measures were being carried out.
- The entire dock area got destroyed along with nearby Monsanto chemical company, smaller companies, wear houses, storage tanks.
- Flying debris prompted more explosions and tidal wave of 13ft(4 Meters) high has swept the dock area, destroyed minimum 1000 residences and buildings.

- Always treat any scene with ammonium nitrate, or any other explosive compound, as just that, an explosive device
- First responders do not have the appropriate PPE to protect ourselves from any energetic material.

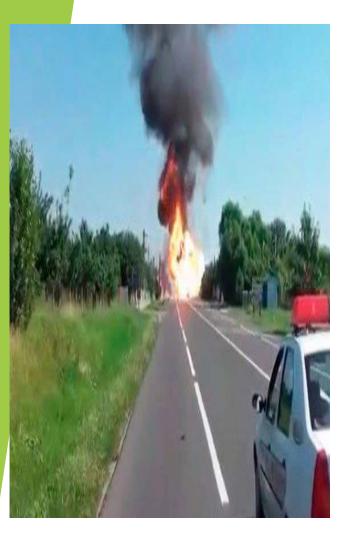
## MAY 24, 2004- MIHALESTI ROMANIA

The consequences of the accidents were catastrophic: - 18 deaths (fire-fighters, local people, reporters, policemen), 11 injured;

- 150 m of E85 road destroyed; 16 houses damaged: windows broken or roof damaged; 6 private cars damaged or destroyed; 2 fire-fighter trucks heavily damaged; electrical supply network of Mihailesti village damaged. Heavy pieces from the truck were projected at hundreds of meters, the central axle of the truck weighting 1.5 t being found in the roof of a house at 250 m from the accident.

- Learning from the incident:
- A general conclusion is that both accidental and deliberate accidents will continue to occur unless best practices are implemented in industry and transportation and unless lessons learned from past accidents are applied. Considering the earthquakes measured at Istria station it can be concluded that two explosions took place in the case of Mihăilesti accident. The first explosion was weaker and a lower TNT equivalency could be associated with it. The second explosion was probably a detonation and a high TNT equivalency should be associated. A more detailed analysis of the Mihăilesti explosion is necessary for the determination of TNT equivalencies.

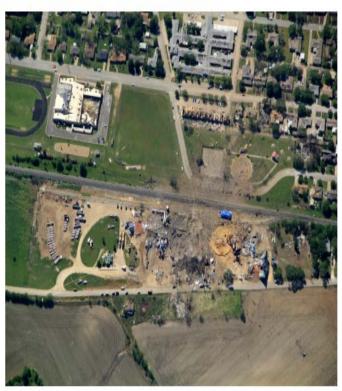
WEST FERTILIZER COMPANY FIRE AND EXPLOSION (15 Fatalities, More Than 260 Injured)

- > On April 17, 2013, a fire and explosion occurred at the West Fertilizer Company (WFC), a fertilizer blending, retail, and distribution facility in West, Texas. The violent detonation fatally injured 12 emergency responders and three members of the public. Local hospitals treated more than 260 injured victims, many of whom required hospital admission. The blast completely destroyed the WFC facility and caused widespread damage to more than 150 offsite buildings

- The explosion happened at about 7:51 pm central daylight time (CDT), approximately 20 minutes after the first signs of a fire were reported to the local 911 emergency response dispatch center. Several local volunteer fire departments responded to the facility, which had a stockpile of between 40 and 60 tons (80,000 to 120,000 pounds) fertilizer grade ammonium nitrate (FGAN), not counting additional FGAN not yet offloaded from a railcar.

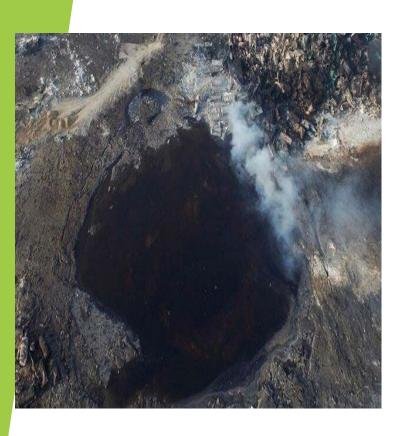
#### AUG 12, 2015- TIANJIN CHINA

Series of explosions that killed over one hundred people and injured hundreds of others occurred at a container storage station at the Port of Tianjin on Wednesday, 12 August 2015. The first two explosions occurred within 30 seconds of each other at the facility, which is located in the Binhai New Area of Tianjin, China. The second explosion was far larger and involved the detonation of about 800 tons of ammonium nitrate. Fires caused by the initial explosions continued to burn uncontrolled throughout the weekend, repeatedly causing secondary explosions, with eight additional explosions occurring on Saturday, 15 August.

The cause of the explosions as per later concluded investigation in February 2016 that an overheated container of dry nitrocellulose was the cause of the initial explosion.

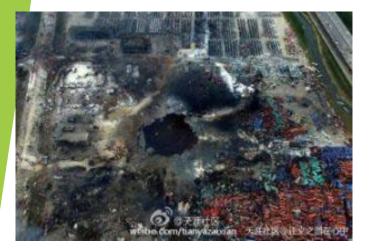
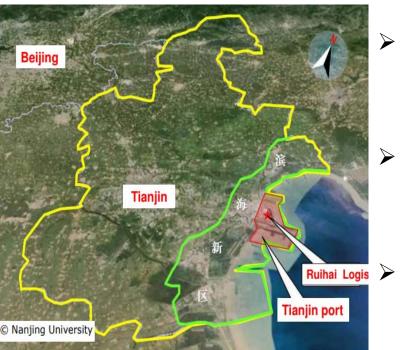
### AUG 12, 2015- TIANJIN CHINA

- As of 12 September 2015, the official casualty report was 173 deaths, 8 missing, and 797 non-fatal injuries.
- ➤ 304 buildings, 12,428 cars and 7,533 containers were badly destroyed.

- ➤ Environment damage: 320.6 tons of sodium cyanide and a large amount of other chemicals were dispersed.
- August 12, 22:51:46: fire, 23:34:06 (~45 min later): the first explosion, 23:34:37 (~30 sec later): the second explosion. August 14, 16:40: the fire was extinguished.

- According to the on-site staffs, the video, the trace evidences, and the destruction and displacement characteristics of the containers, the central area of the dangerous goods container storage station was identified as the initial fire point.

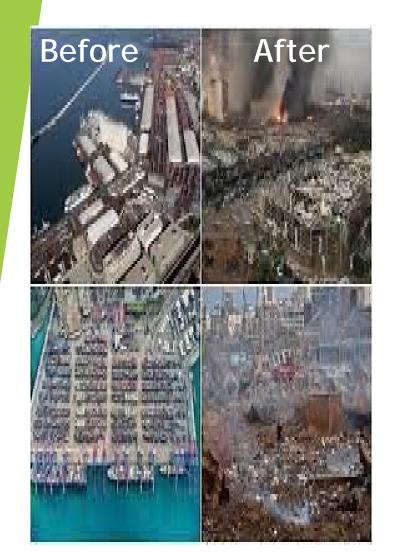
## AUGUST 04 2020-BEIRUT, LABANON

- ➤ The Beirut port Ammonium Nitrate explosion killed 218 people, including nationals of Lebanon, Syria, Egypt, Ethiopia, Bangladesh, Philippines, Pakistan, Palestine, the Netherlands, Canada, Germany, France, Australia, and the United States.

- ➤ It wounded 7,000 people, of whom at least 150 acquired a physical disability; caused untold psychological harm; and damaged 77,000 apartments, displacing over 300,000 people.

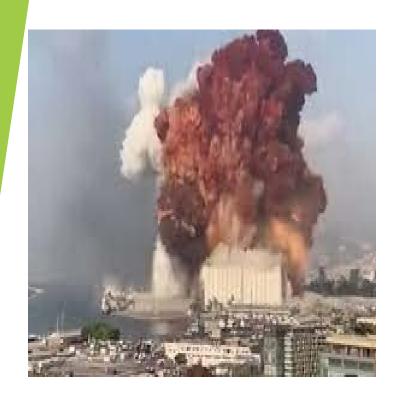
## AUGUST 04 2020-BEIRUT, LABANON

- ➤ It resulted in ammonia gas and nitrogen oxides being released into the air, potentially with toxins from other materials that may have also ignited as a result of the explosion. Ammonia gas and nitrogen oxides are harmful to the environment as well as to the respiratory system.

- ➤ Destruction is estimated to have created up to 800,000 tonnes of construction and demolition waste that likely contains hazardous chemicals that can damage health through direct exposure, or soil and water contamination.
