Explosion in a Tank

EPSC Learning Sheet April 2022

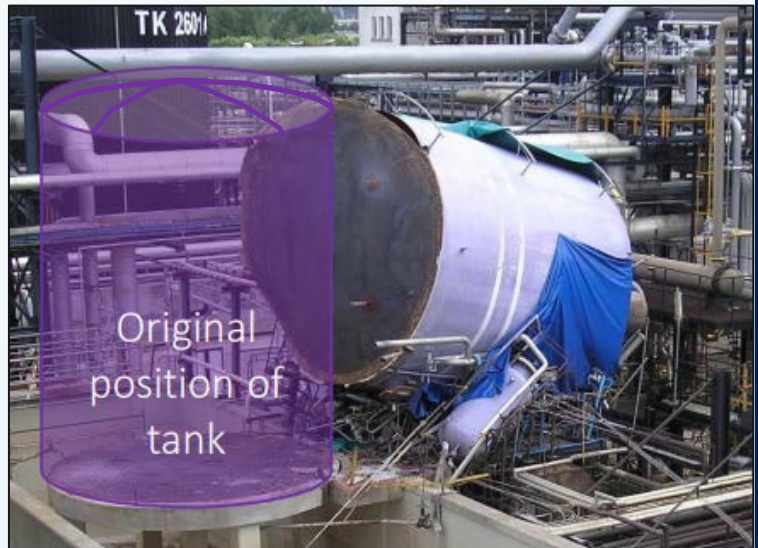
A Sulfuric acid tank was emptied, aerated and prepared for inspection. During removal of rusted bolts of a cover on the tank roof using a grinder, an explosion occurred. Hydrogen had collected under the tank roof.

- Concentrated Sulfuric acid with some water becomes very corrosive for carbon steel and generates hydrogen:
$$\text{H}_2\text{SO}_4 + \text{Fe} \rightarrow \text{H}_2 + \text{FeSO}_4$$
- Measuring the presence of flammable gas was done at the manhole (entry) at the bottom of the tank. The explosive mixture (hydrogen/air) however accumulated under the dome at the top of the tank.
- Hydrogen in air has a very wide explosive range, it has a very low ignition energy at stoichiometric concentration and leads easily to a violent deflagration or detonation upon ignition. Assure top venting of acid tanks that are prepared for maintenance and inspection.
- Avoid accumulation of hydrogen at high locations.
