Chlorine Leak

EPSC Learning Sheet March 2023

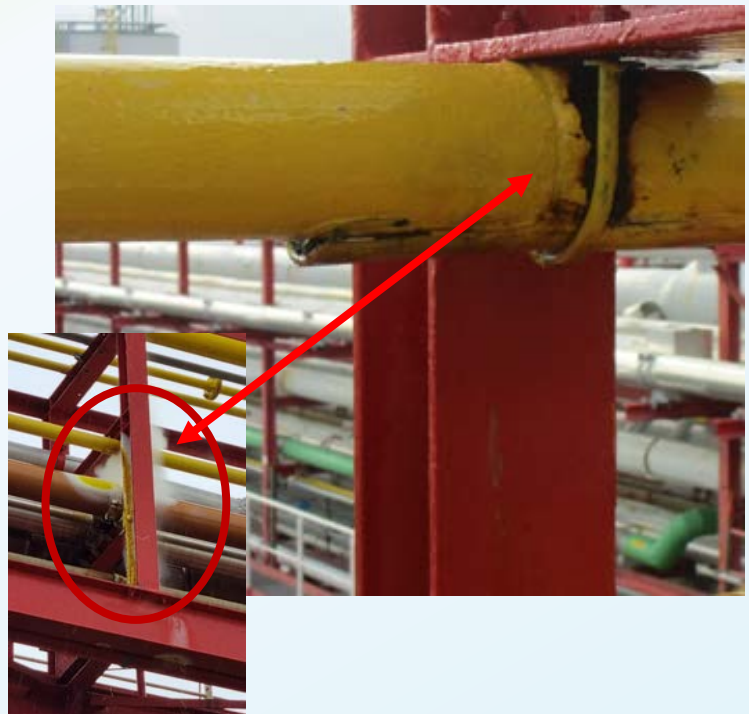
A DN80 pipeline with 7 bar liquified Chlorine started to leak at the point where the pipeline is connected to the plant construction. The pipeline was high in a pipe-bridge without easy access for inspection, that was done 6 month ago. It missed this critical point.

- Pipe connections to the plant construction are potential weak points with enhanced erosion and corrosion.
- The pipe must be free hanging, allowing expansion. Such a profile allows that Plastic supported by metal reduces friction.
- Drones might be used to help inspections at difficult to reach places.
- Design pipe routing and supports in a way to enable visual inspection from all sides, avoid hidden spots.
- Critical points in pipelines that require additional attention during inspection include: spots with water retention, support points, dead legs, changes in pipe spec, vibration areas, spots with cyclic stress and thermal expansion.
