Asphalt dust explosion

EPSC Learning Sheet July 2023

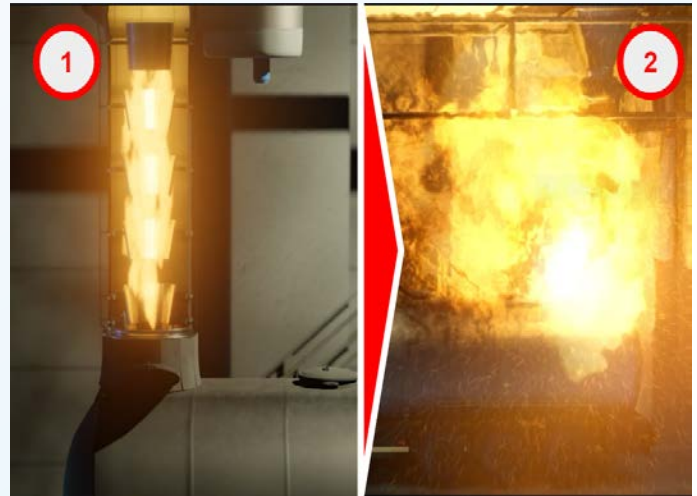
During the loading of solid asphaltene into a trailer, a primary dust explosion occurred inside a loading bellow due to a faulty bonding of a bellow support cone. The primary explosion dispersed dust and set up a secondary explosion inside the loading hall.

- Ensure that Dust Hazard Analyses are performed using industry best practices and correct dust characteristics (e.g. minimum ignition energy or temperature).
- When testing the explosion properties, always use the smallest possible dust particle and verify the actual particle size when in operation (verify your DHA risks in the real world).
- Housekeeping is a crucial measure to prevent secondary explosions. Often the first explosion disperses more dust and sets up the more severe secondary explosion.
- Implement adequate and effective protection systems and safeguards against dust explosion.
- Assure correct and reliable bonding and grounding of metal parts. The solid asphaltene fell through the bellow metal support cones into the trailer. The bonding cable of the last cone was not well connected causing an ignition due to static discharge.

Small dust particles of combustible solids can be ignited by a static electrical discharge
