# ARE WE REALLY LEARNING" A Case study- Still Going Wrong" PRAKASH TATA, Author

This Presentation which is part of my forthcoming book titled "Are We Really Learning?" whose idea got inspiration from Last ASSP PDC where I got inspiration to go through all global catastrophic incidents. In this book I am working on a new age "Process Safety Management" process - "MLW-CAR-TOWARDS SOCIETAL RISK"

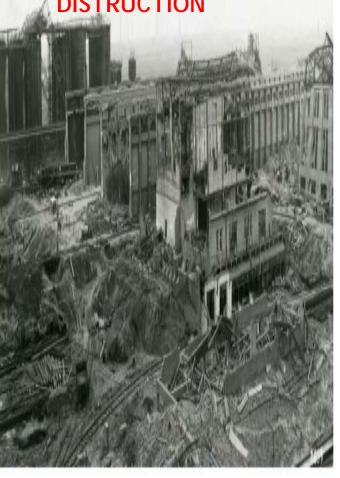
#### NEIGHBOURHOOD DISTRUCTION

- It can be assumed that on the day of the accident at least one of the explosions for loosening the caked salt was carried out in the area of the fine fraction, thus initiating a detonation of this fine fraction and causing the detonation of further fractions with approximately "normal" nitrate content.
- This accident is a strong example for the need of Management of Change (MOC) procedures, which are an integral part of today's process safety.
- ➤ Lack of care by operators induced by introduction of a new bonus system which was linked to the production quantity
- Introduction of the new spray process Deviations from the operating procedures resulting in the addition of wrong amounts of AS (too little) or AN (too high)
- Fine dust in 100 of tons ignored settling down with a thickness of 0.5m has created as dust cloud which lead to the explosion.

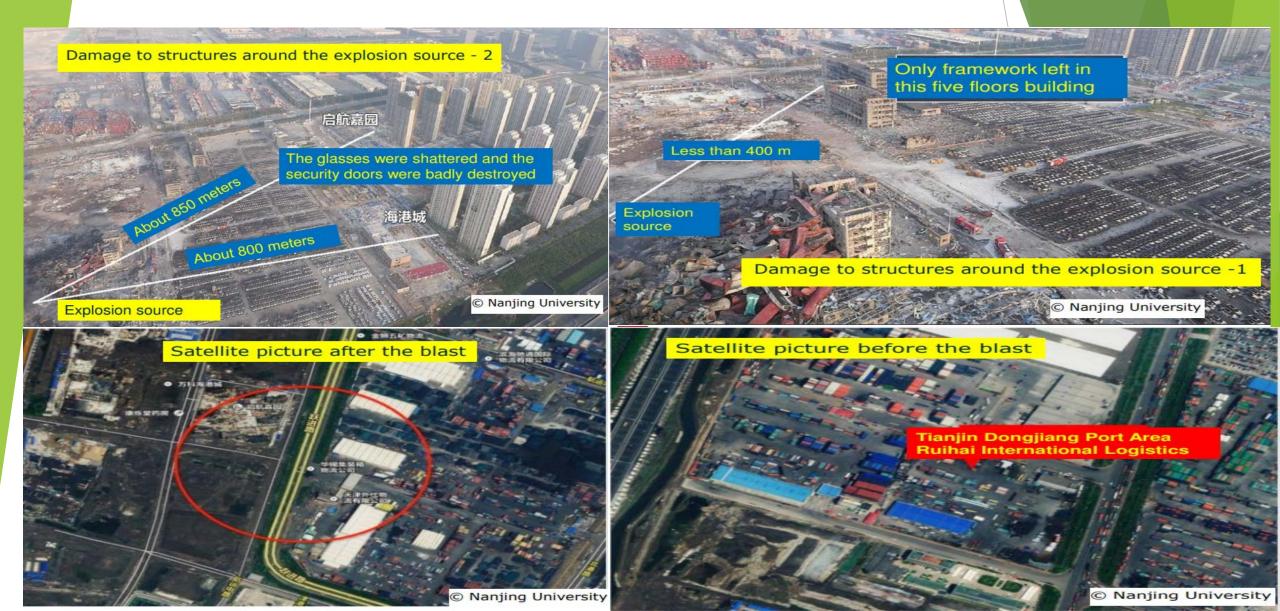
## AUG 12, 2015- TIANJIN CHINA

Series of explosions that killed over one hundred people and injured hundreds of others occurred at a container storage station at the Port of Tianjin on Wednesday, 12 August 2015. The first two explosions occurred within 30 seconds of each other at the facility, which is located in the Binhai New Area of Tianjin, China. The second explosion was far larger and involved the detonation of about 800 tons of ammonium nitrate. Fires caused by the initial explosions continued to burn uncontrolled throughout the weekend, repeatedly causing secondary explosions, with eight additional explosions occurring on Saturday, 15 August.

The cause of the explosions as per later concluded investigation in February 2016 that an overheated container of dry nitrocellulose was the cause of the initial explosion.

- As of 12 September 2015, the official casualty report was 173 deaths, 8 missing, and 797 non-fatal injuries.
- ➤ 304 buildings, 12,428 cars and 7,533 containers were badly destroyed.

- ➤ Environment damage: 320.6 tons of sodium cyanide and a large amount of other chemicals were dispersed.
- August 12, 22:51:46: fire, 23:34:06 (~45 min later): the first explosion, 23:34:37 (~30 sec later): the second explosion. August 14, 16:40: the fire was extinguished.

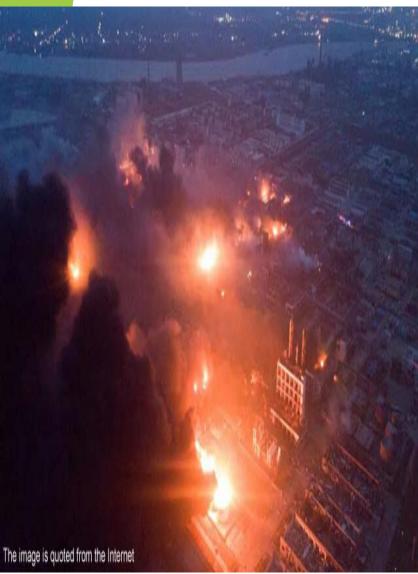
#### MARCH 21 2019-CHEMGIANJANG, CHINA

The March 2019 explosion occurred at a local time of 14:48 (06:48 GMT). 78 people were killed, and at least 94 were severely injured, 32 of whom were critically injured.

Around 640 people required hospital treatment and were taken to 16 hospitals.

The injured included children at a local kindergarten. CNEC detected an M<sub>1</sub>2.2 artificial earthquake whose epicenter is at 34.331°N 119.724°E. The force of the blast started numerous fires in Yancheng, knocked down several buildings, and reportedly destroyed windows several kilometers away. The fire was reported to have been controlled by 03:00 local time. Considerable damage was caused to nearby factories and offices; the roof of Henglida Chemical Factory, 3 km from the explosion, fell in. At least one of the people killed was in another building destroyed by the blast. Windows are reported to have been blown out up to 6 km away from the explosion, and houses and other buildings were damaged in the nearby village-level administrative divisions including Town (Haianju) and Shadang. This explosion was strong enough that it registered on earthquake sensors and could be seen by satellites. The blast created a crater resulting in a magnitude 2.2 seismic shock that took over 900 firefighters to get the fire under control.
